The Front Range Pine Type

A 40-Year Photographic Record of Plant Recovery on an Abused Watershed

Howard L. Gary and Pat O. Currie

USDA Forest Service
General Technical Report RM-46
November 1977

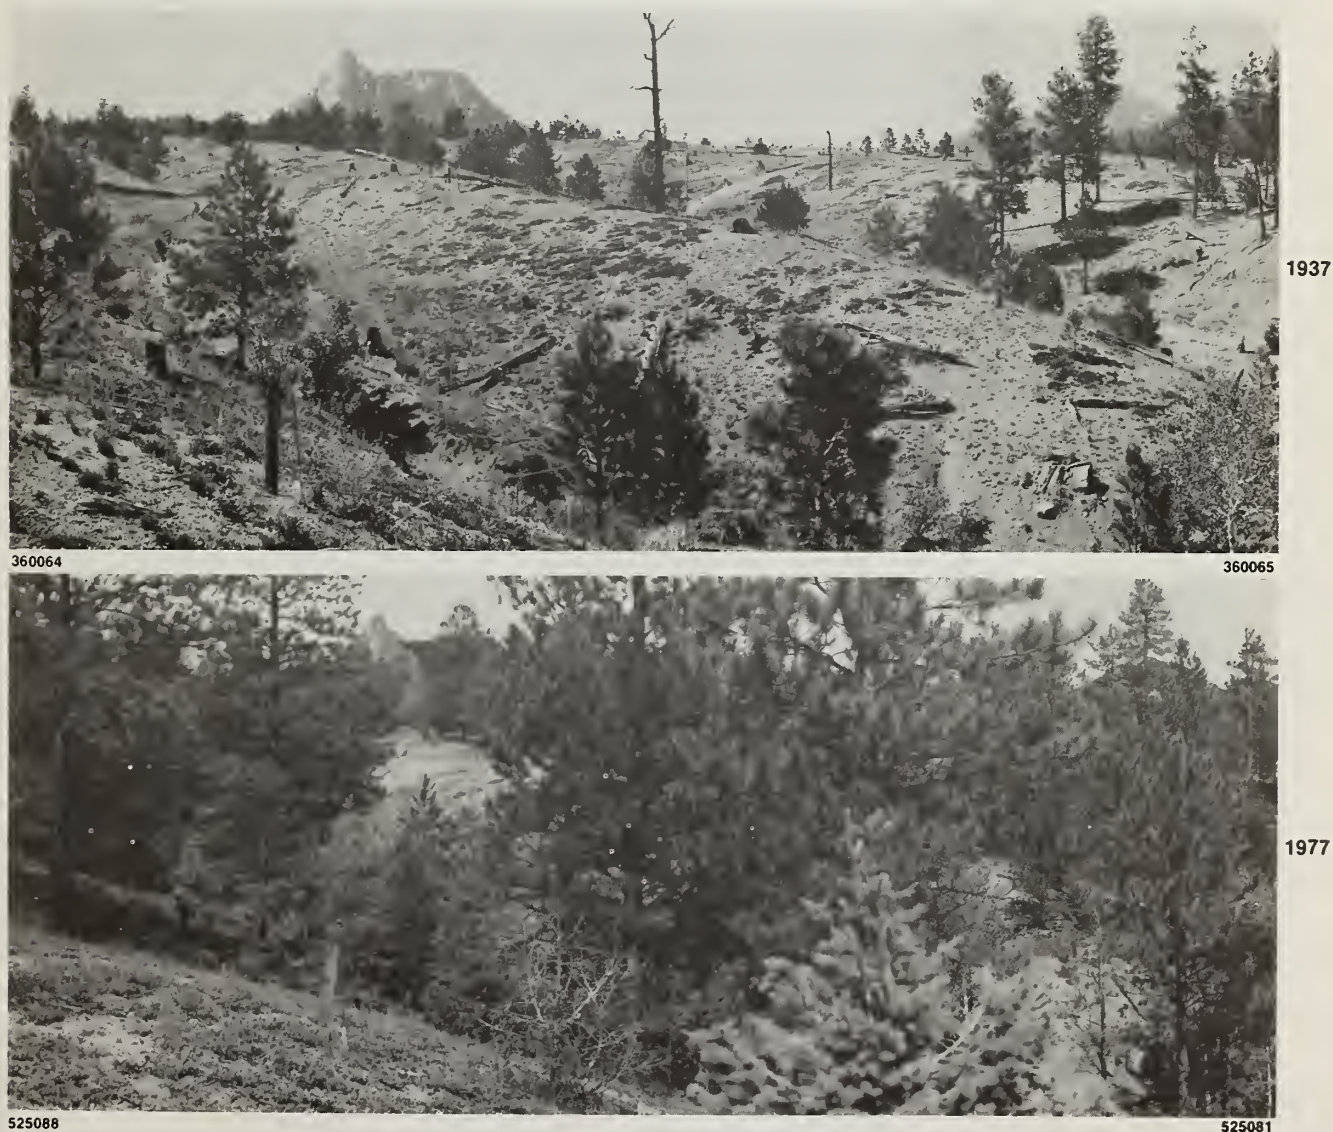
Figure 3.—Panoramic view from camera point No. 9. Sheep Nose is in the left background.

After 40 years of recovery and soil stabilization, a panoramic view of the central portion of the Trail Creek watershed as it appeared in 1937 and 1977 is best illustrated from camera point 9 west and northwest (fig. 3). Most of the stumps visible in the 1937 photographs were fire scarred. Their spacing

indicates the original pine forest was rather open. Topography is typical of the entire watershed and shows the easy accessibility for early logging and downhill skidding using teams of horses. Ground cover in 1937 was mainly bearberry, mountain muhly, and blue grama. The tree cover in 1977 masks the topography but shows the land has capacity for natural regeneration and low grade timber growth, if given sufficient time. A high density mat of bearberry dominates the lower left foreground of the 1977 photos and shows local stabilization of the site.

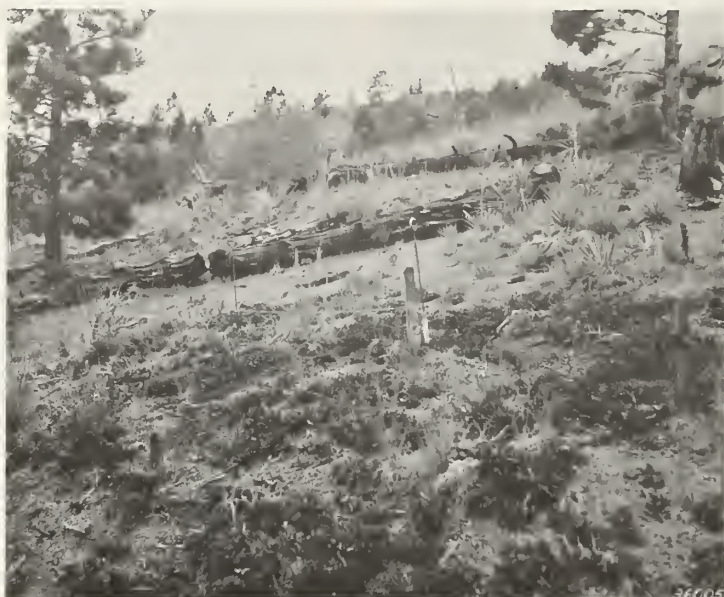
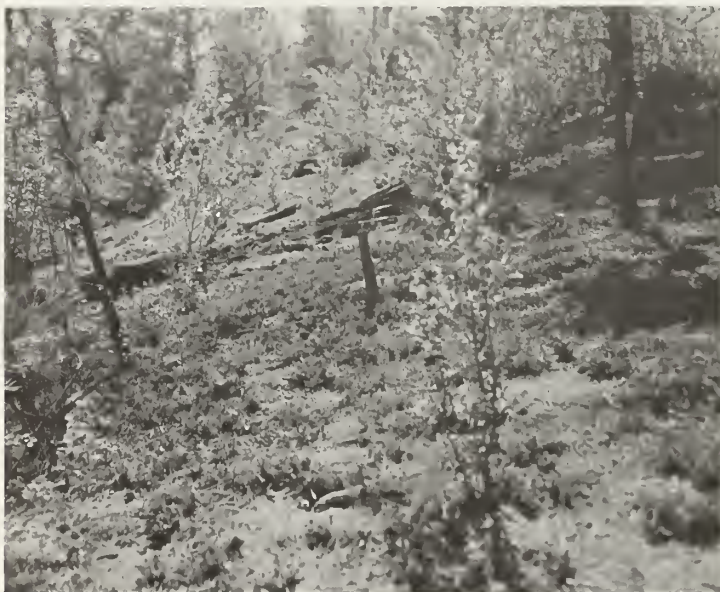
Figure 4.—Bearberry cover at camera point No. 38.

were still present and had expanded by 1977 (camera point 38, fig. 4). Bearberry appears to be a long-lived plant when left undisturbed, is tolerant of partial shade, and provides good local soil stabilization. True mountainmahogany, a desirable browse plant, is also now plentiful in the same area. Yucca and some of the grasses appear to have decreased because of partial shade provided by the surrounding trees.

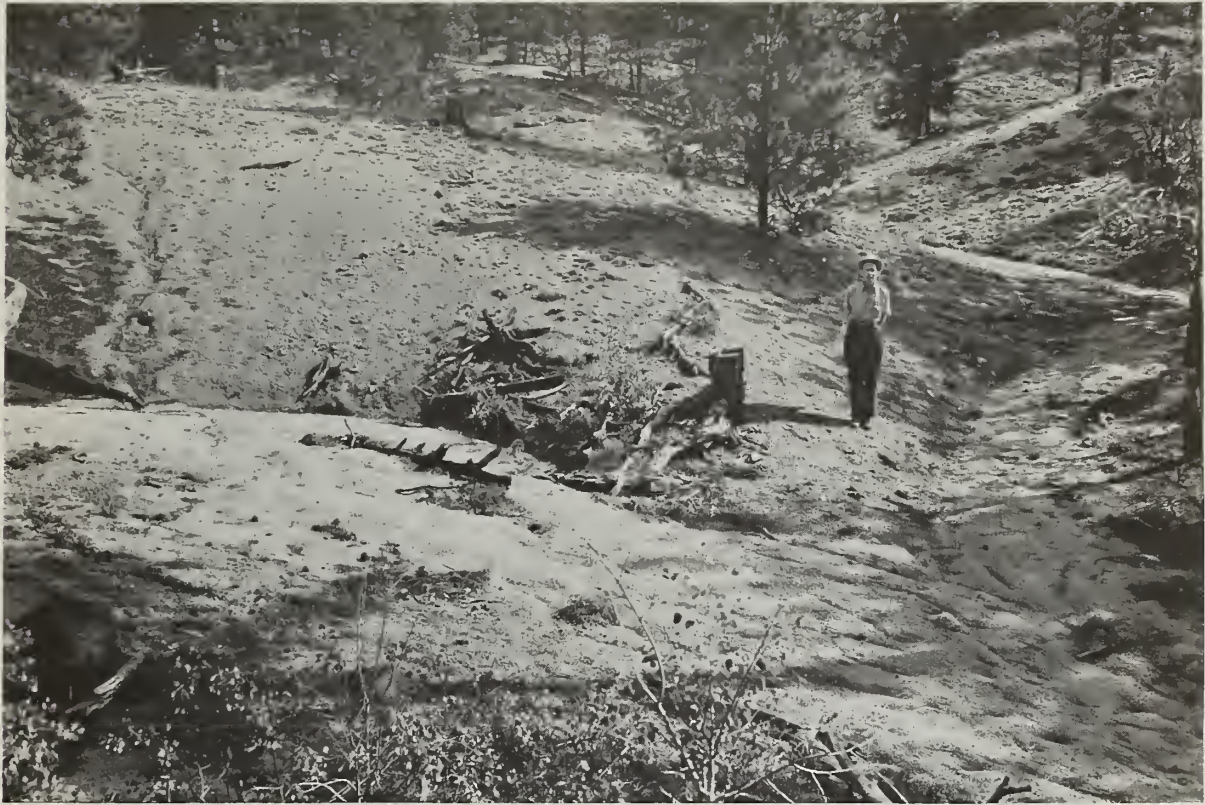
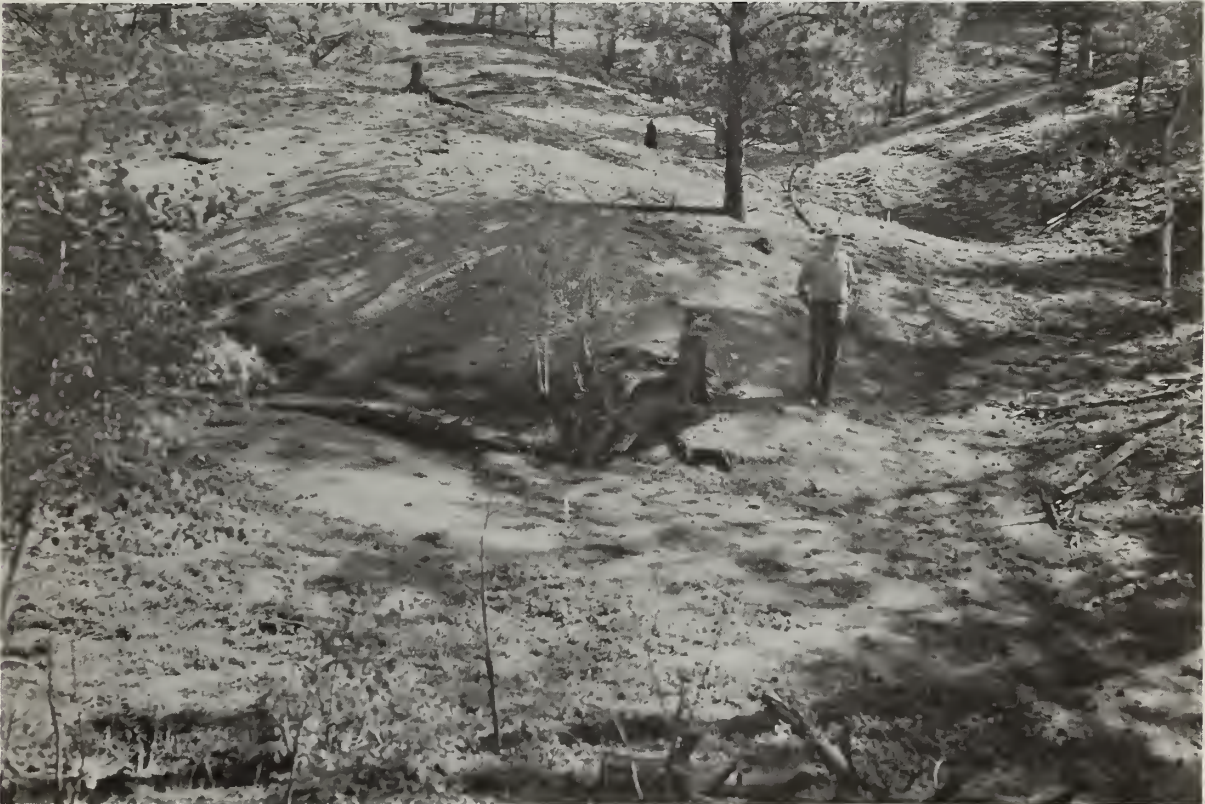
Figure 5.—Confluence of two drainages at camera point No. 2.

It is of interest to note that areas of bare ground visible in 1937 were generally bare in 1977 (camera point 2, fig. 5). The lack of cover attests to the harshness and shallow soils of many sites which

inhibit natural plant establishment. Also, as shown in camera point 7 west (fig. 6), the steep bare slopes which today one might expect to have eroded because of lack of vegetation have changed little in 40 years. Close examination reveals that some sheet erosion has occurred, but the steep slope has not

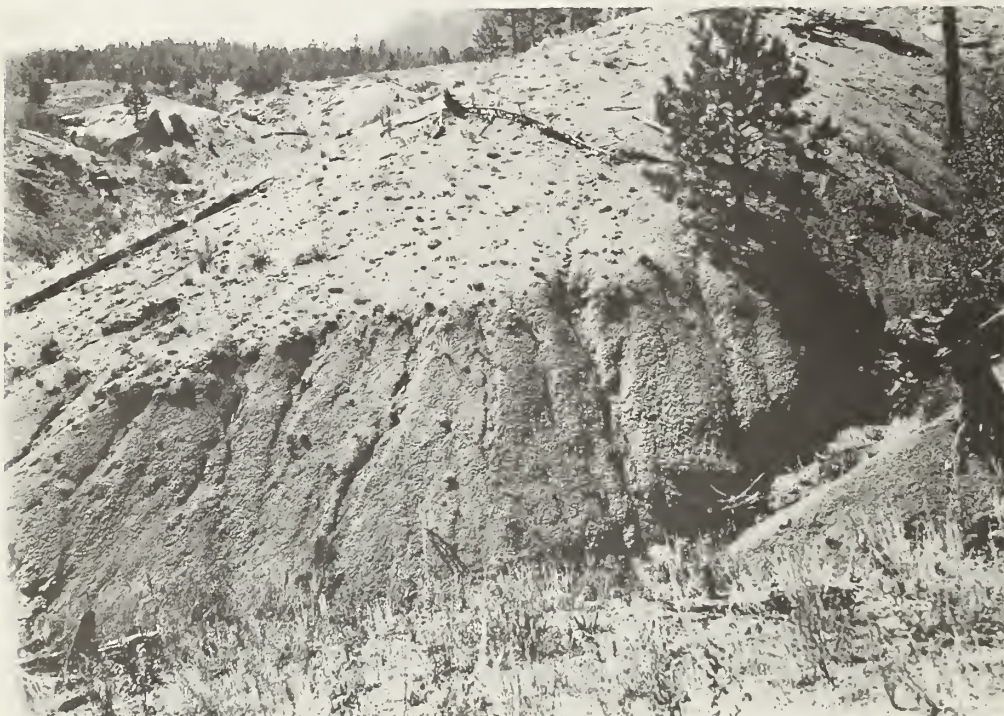
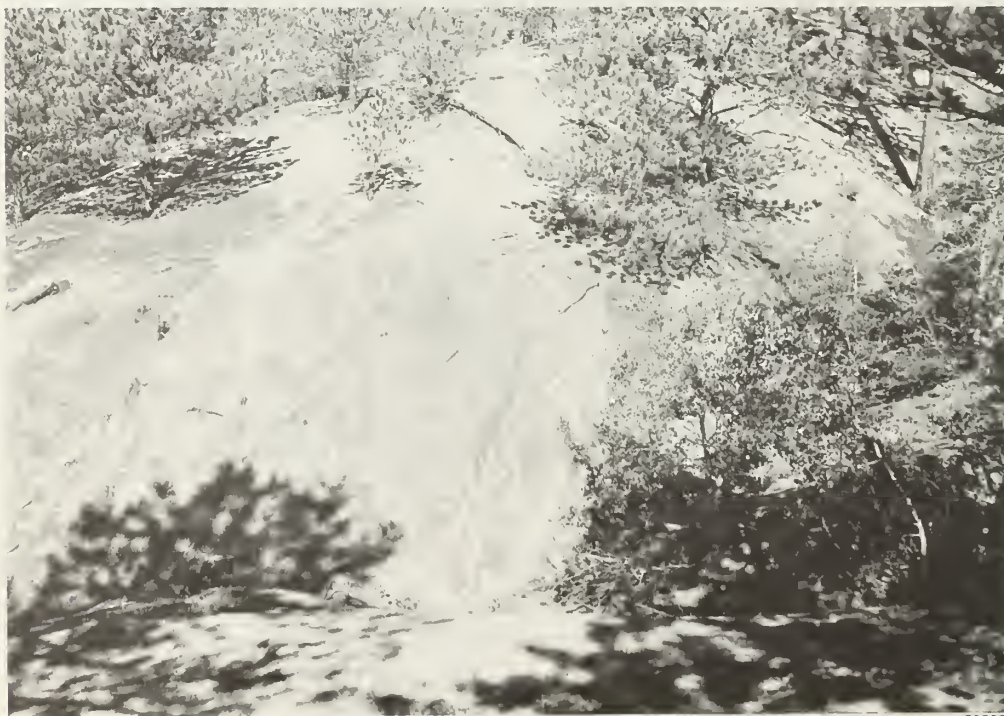
Figure 6.—Steep slope west of camera point No. 7.

been deeply incised with new gullies. The steep slope was somewhat more rounded in 1977 but appears relatively stable for the average local climate. It appears that regeneration of trees and resultant needle drop have helped stabilize the topography.

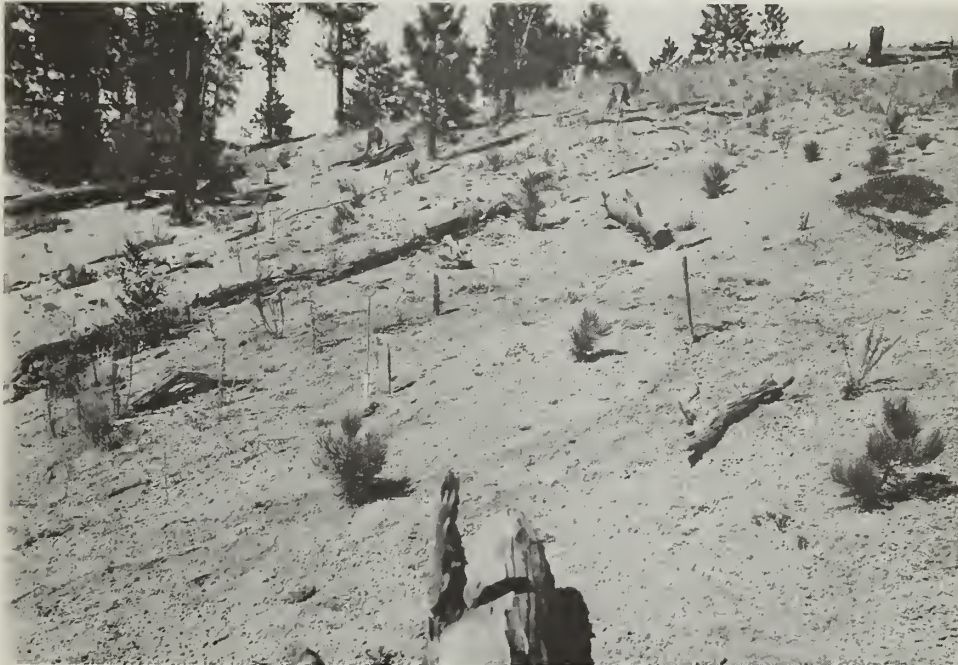
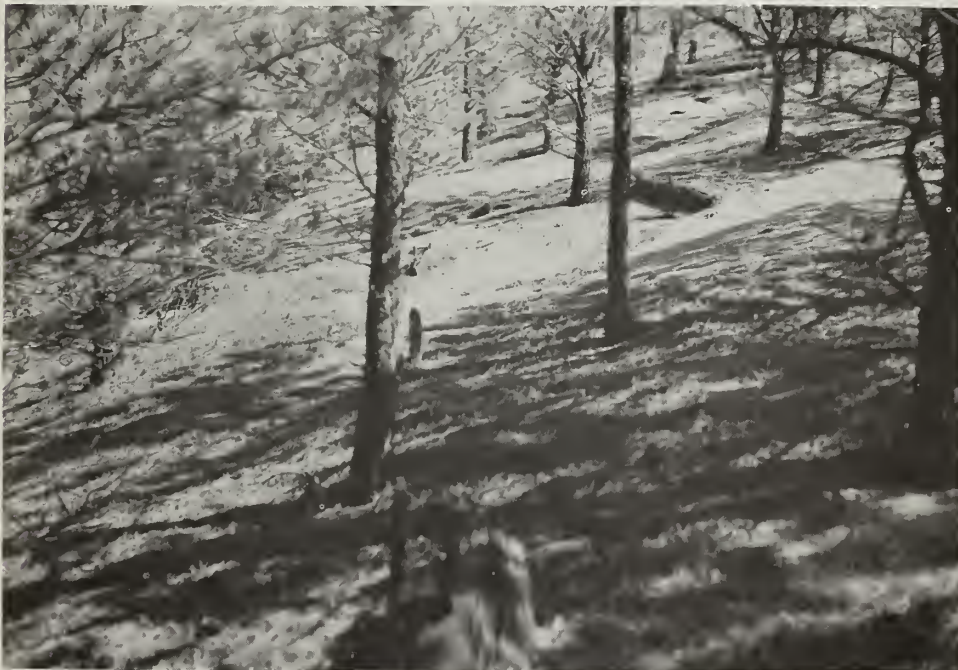
Figure 7.—Reforested south facing slope at camera point No. 7.

In the same area, at camera point 7 north (fig. 7) tree growth was also slow on the bare south facing slope planted to ponderosa pine. Estimated tree heights averaged 4.2 m (13.8 feet), and measured diameters averaged 11.7 cm (4.6 inches). This slow growth appears to be a reflection of the harsh dry microclimate of south slopes. This harshness also limits understory plant growth, and little vegetation was present in 1977. A protective cover of pine

needles was forming, however, and in time will add further protection to the site. All photos at camera point 7 (figs. 6 and 7) illustrate that without disturbance these areas are rather stable even though vegetation recovery is slow. Based on the 40-year time span, the amount of cover vegetation or dead organic matter, will be limited for many more decades and will be critical to the preservation of the soil resource.

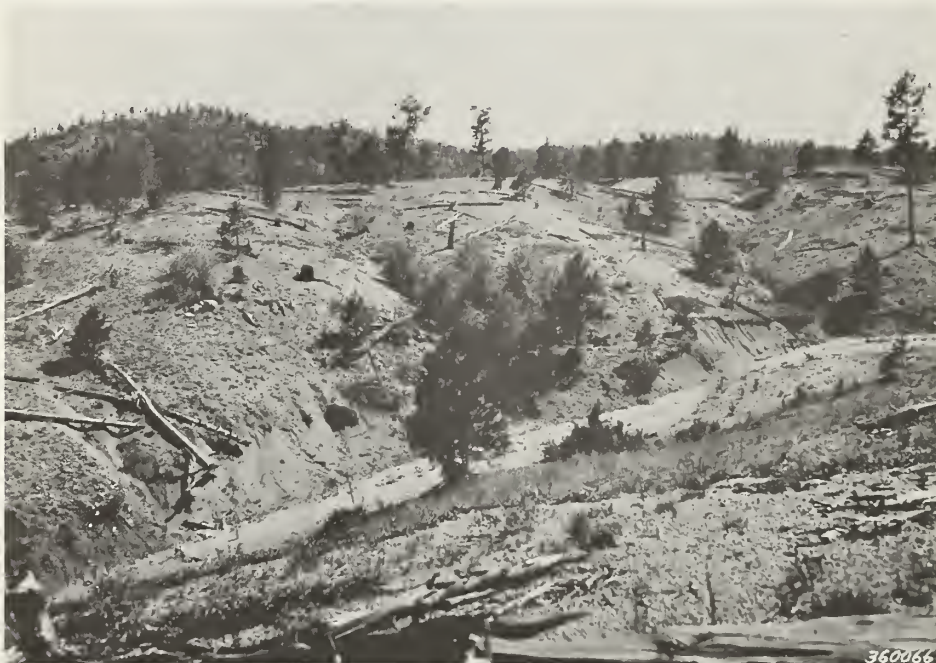
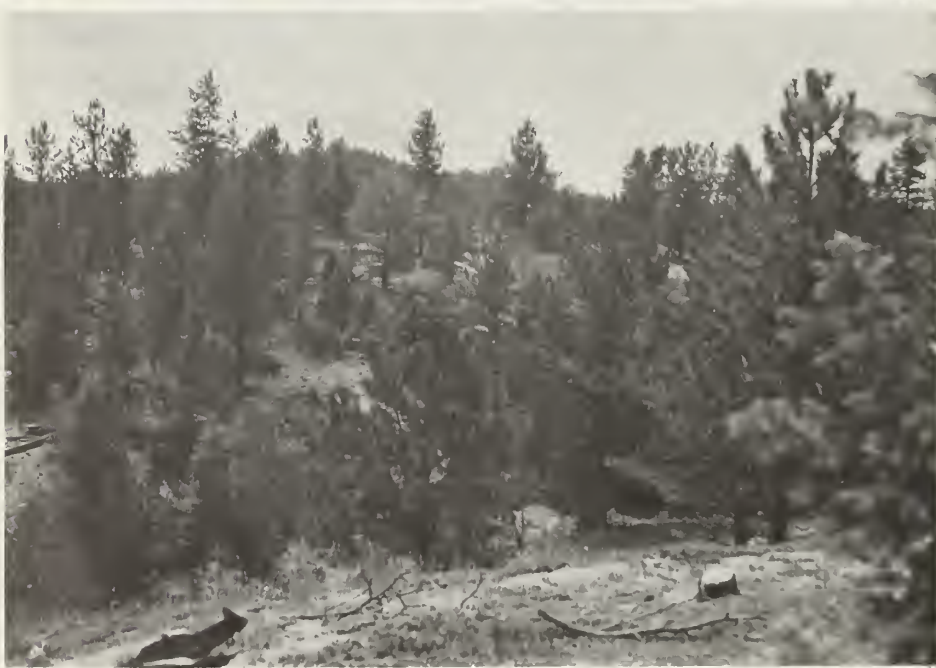
Figure 8.—View south of camera point No. 9.

Examples of artificial and natural reforestation on two north facing slopes near the center of the watershed are shown in camera points 9 south and 13 south (figs. 8 and 9). The site shown in figure 8 was planted to ponderosa pine in the early 1930's, and growth of the surviving trees was rated good for the site. The understory vegetation consisted mainly of bearberry and mountain muhly which changed little in 40 years. The apparently more moist site shown in figure 9 was not planted to

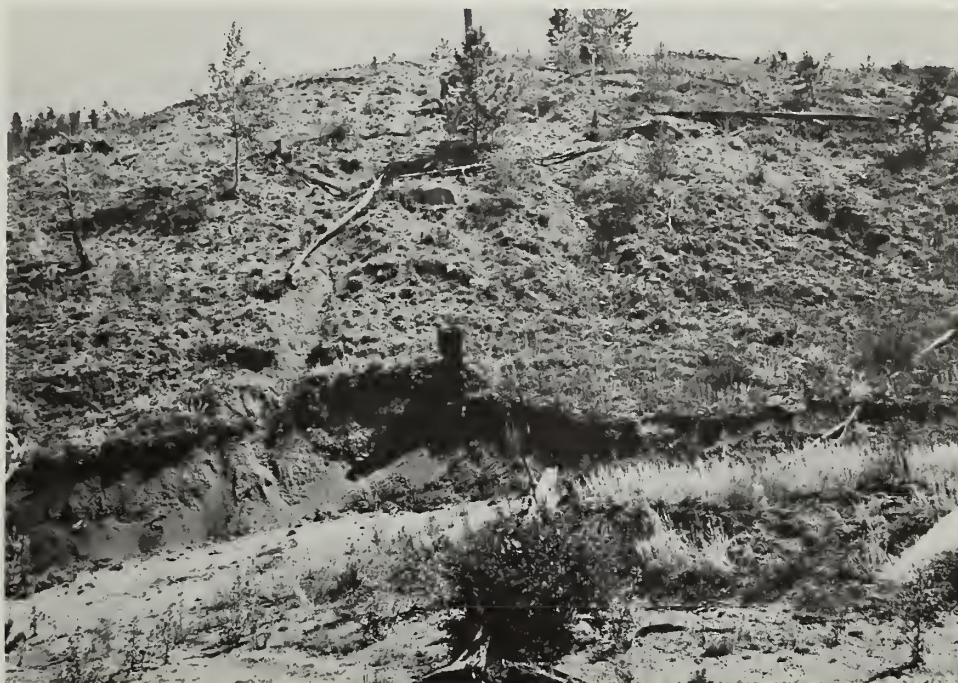
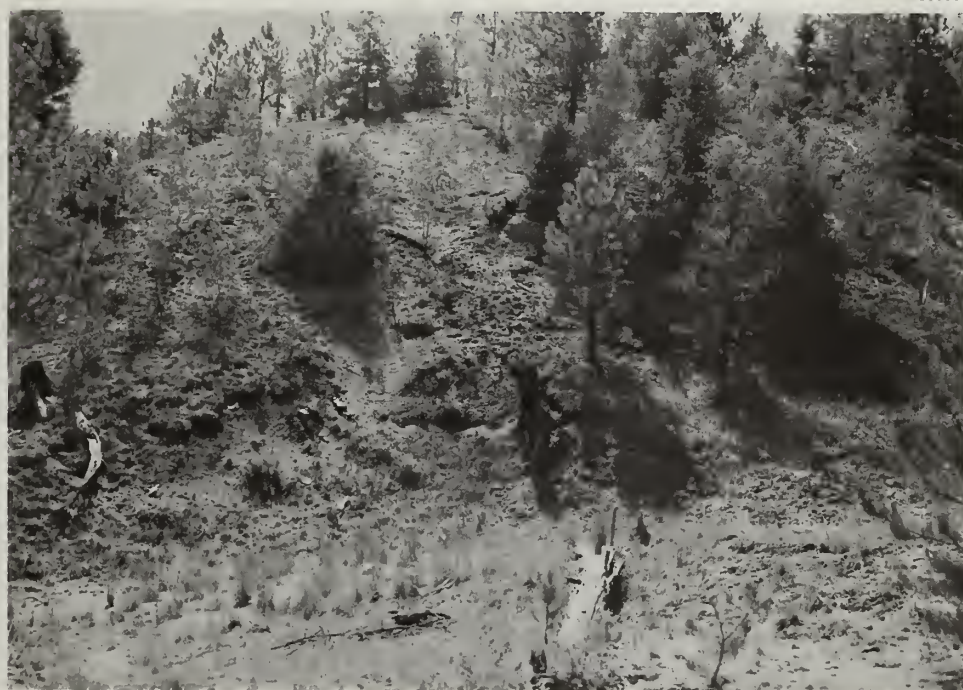
Figure 9.—North facing slope at camera point No. 13.

trees. It may have been thought adequately stocked and that aspen would dominate and stabilize the site, or that protection from grazing alone would allow reforestation to occur. At any rate, the stage of natural reforestation with conifers on this site appears many years younger than that observed on the planted site shown in figure 8. In time, the Douglas-fir also present on the site shown in figure 9 will outgrow any trees now on the planted site.

Minor soil sloughing is still occurring near the toe of the slope shown in figure 9, but the bankside present 40 years ago appears to be stabilizing. Based on comparison of the two sites shown in figures 8 and 9, it is clear that early successful tree planting on depleted sites will result in earlier watershed stabilization and earlier recovery of wood production. Apparently because of higher

soil moisture for the site shown in figure 9, there was a greater diversity of ground cover than at any other photo station. The principal plants were mountain muhly, little bluestem, blue grama, prairie junegrass, *Stipa* spp., *Bromus* spp., Kentucky bluegrass, *Carex* spp., fringed sagebrush, and other *Artemisia* spp.

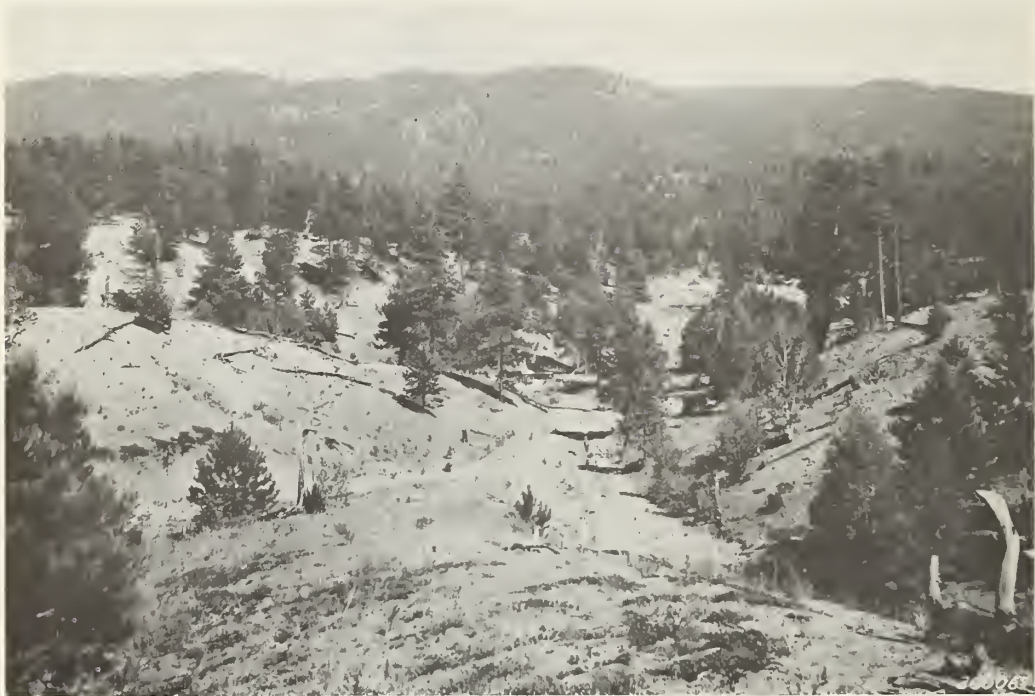
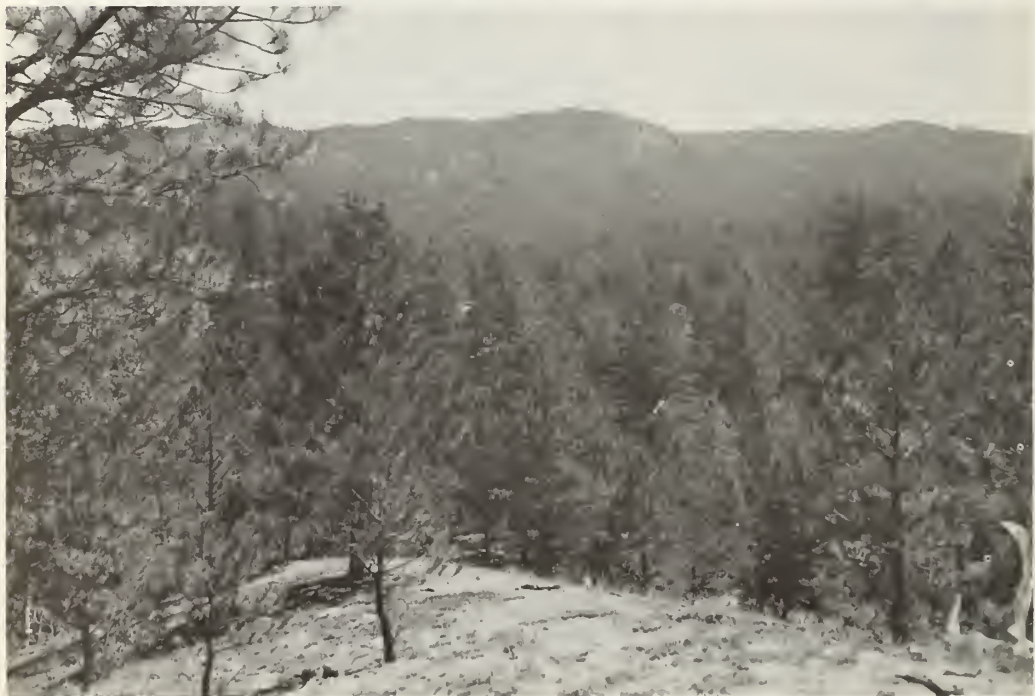
Figure 10.—View east of camera point No. 9.

The eastern boundary of the Trail Creek watershed was visible from camera point 9 east (fig. 10). The mountain range on the skyline was not heavily logged during the late 1800's because of low quality trees and steep terrain. The foreground area was successfully planted to ponderosa pine in the early 1930's. As observed in most other areas of the

watershed, ground cover has changed little as a result of protection from grazing. In the immediate foreground of figure 10, it appears that density of blue grama and *Yucca* spp. has increased slightly and that bearberry has declined. Observations on the ground substantiate this photographic impression.

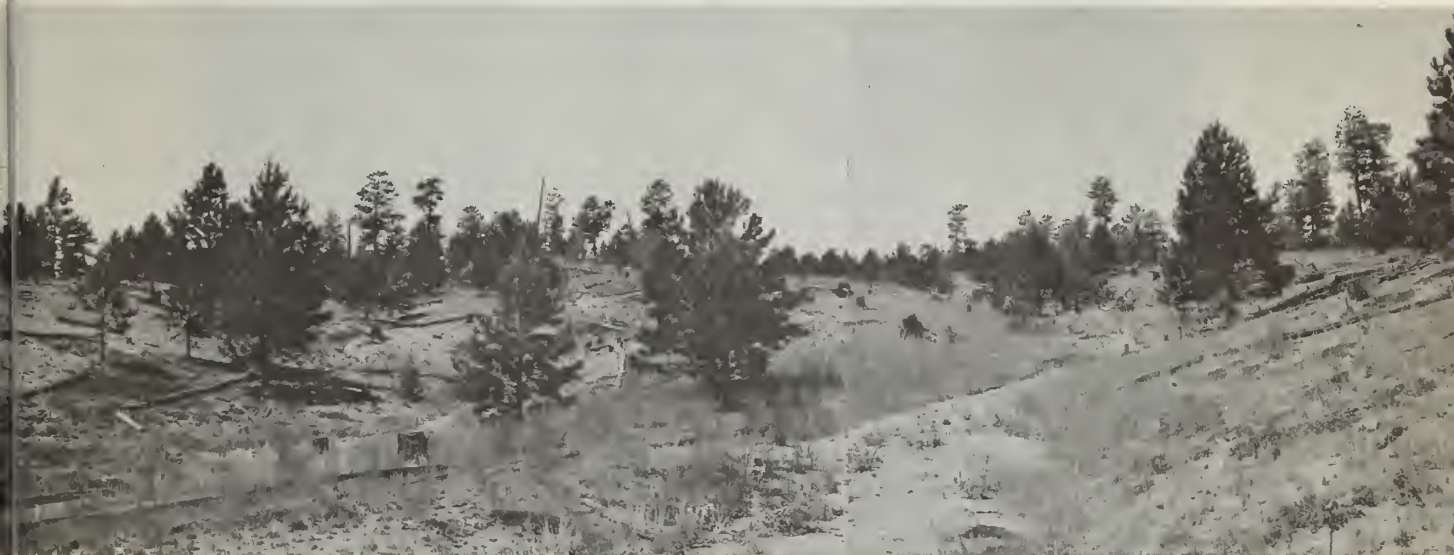
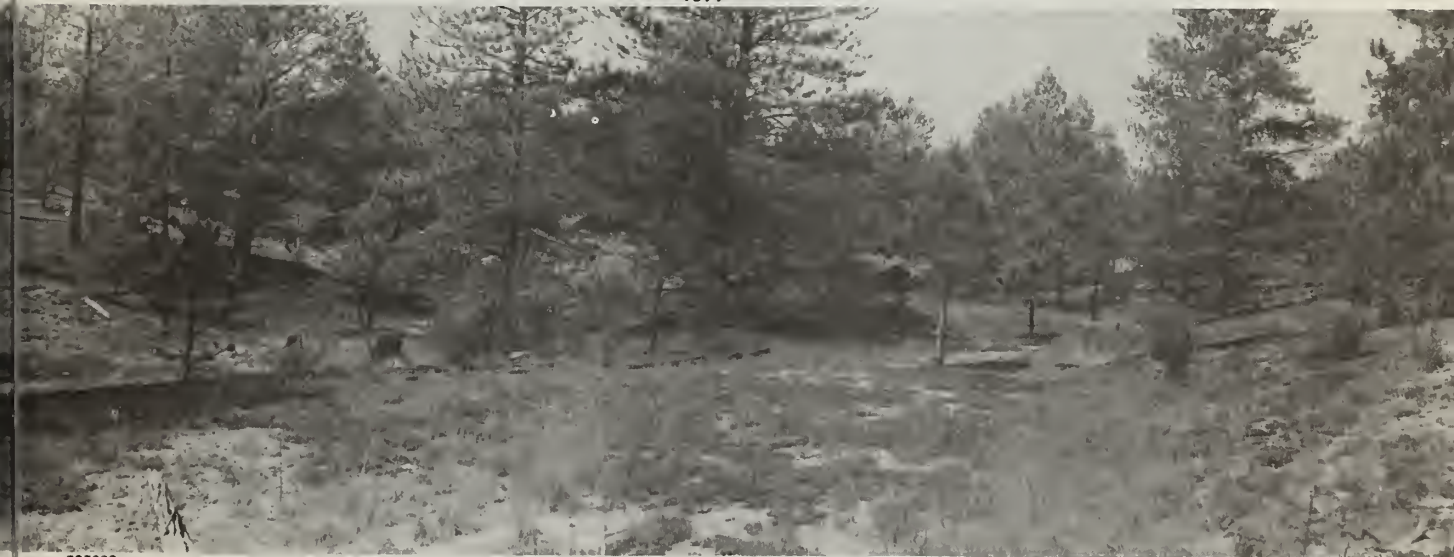
Figure 11.—Panoramic view west from camera point No. 18.

A panoramic view of plant community change in an open ponderosa pine stand is illustrated by the west-southwest views from camera point 18 (fig. 11). The density of the herbaceous ground cover shown in the foreground increased substantially in the drainage bottom, but only slightly on the slopes after 40 years of protection. The watercourse seems to have stabilized with the increased vegetation. The main grasses today are little bluestem, blue grama and mountain muhly. Bearberry density

appears to have increased more than the density of the palatable grasses listed above. True mountainmahogany plants are in greater abundance today than in 1937. Some specific plants are in the same locations, suggesting long-lived plants and some capability to recover from severe overbrowsing. The new trees present in figure 11 in 1977 were the result of natural regeneration, and, in time, true mountainmahogany and ponderosa pine will likely occupy the grassy foreground.

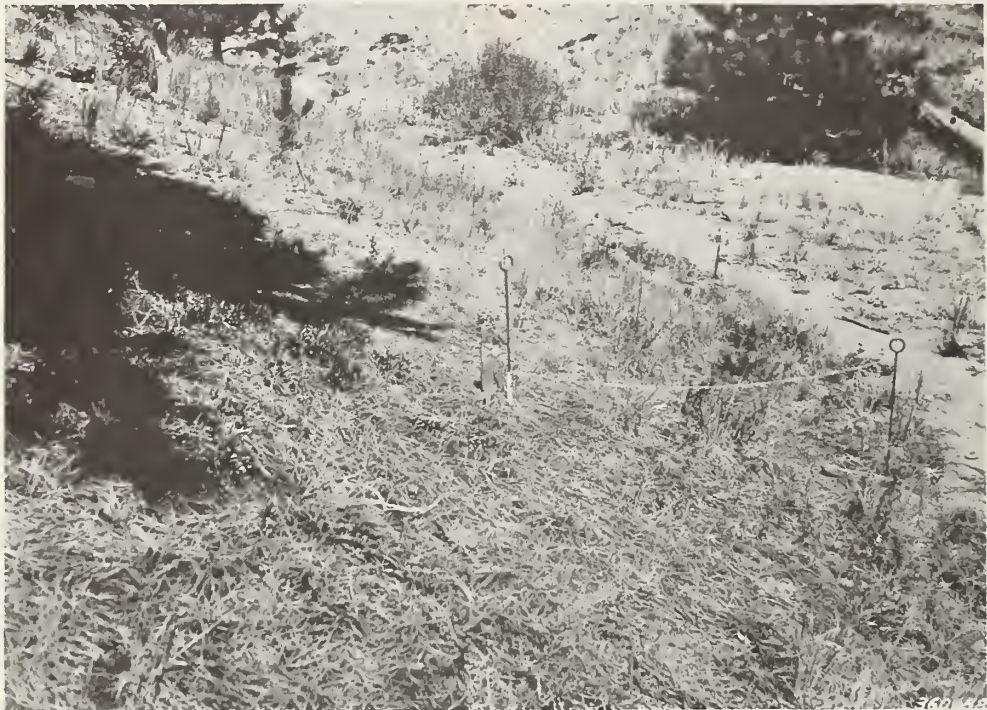
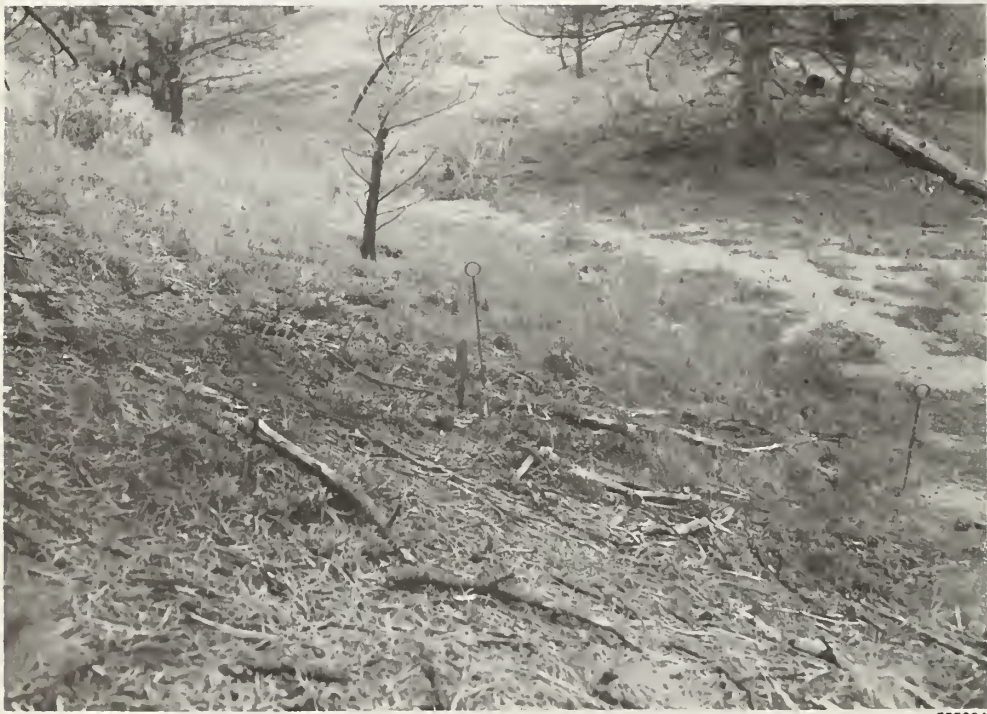
Figure 12.—Litter mat under ponderosa pine at camera point No. 25.

itself for some period beyond the life of the trees. An example of a heavy litter cover was present at camera point 25 (fig. 12) where encroachment by herbaceous vegetation has changed little in 40 years. The small draw also shows little evidence of sedimentation or erosion.

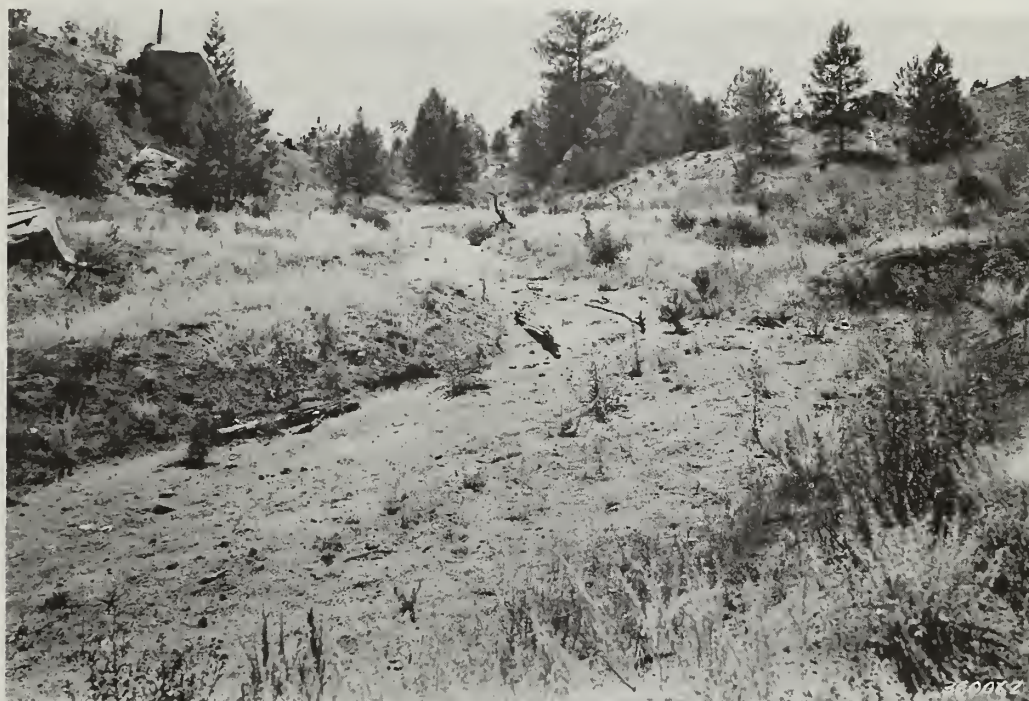
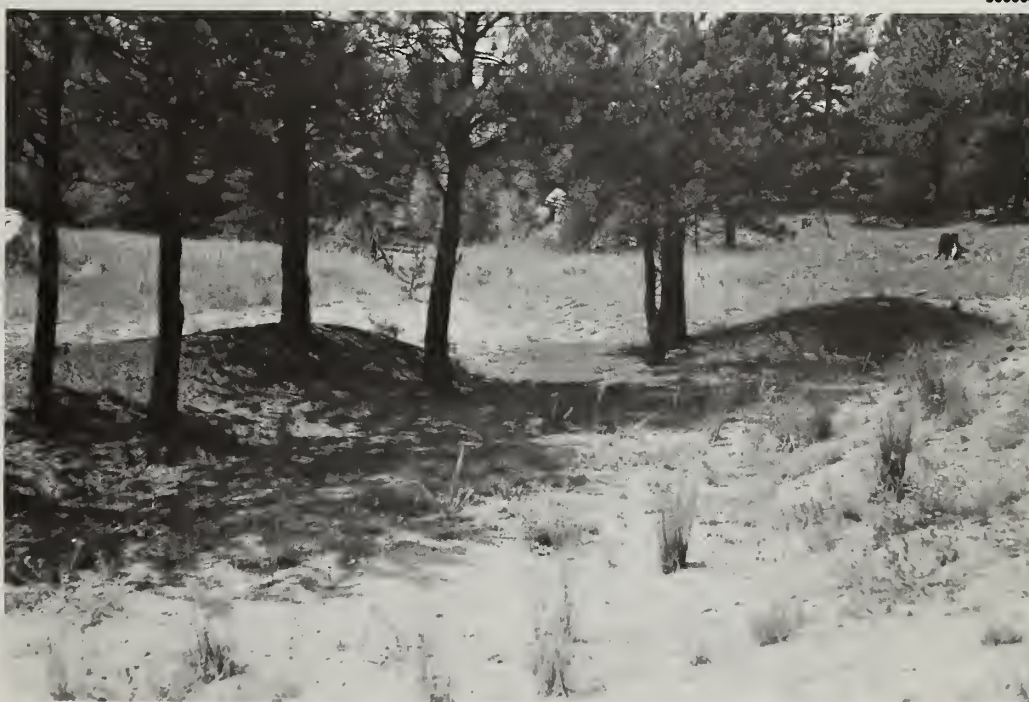
Figure 13.—Drainage west of camera point No. 13.

No widespread accelerated erosion was found in any of the arroyos within the watershed. At camera point 13 west (fig. 13), the photograph for 1937 shows a definite channel and general evidence that water periodically flowed down the channel. The channel is well defined today, but there was no apparent evidence of recent water flows. The lack of

any recent flows may simply reflect storm size and frequency of occurrence. The lack of erosion may also reflect recent stability of the site. The average diameter of trees in the foreground is 20.6 cm (8.1 inches) and estimated average height is 6.6 m (21.5 feet).

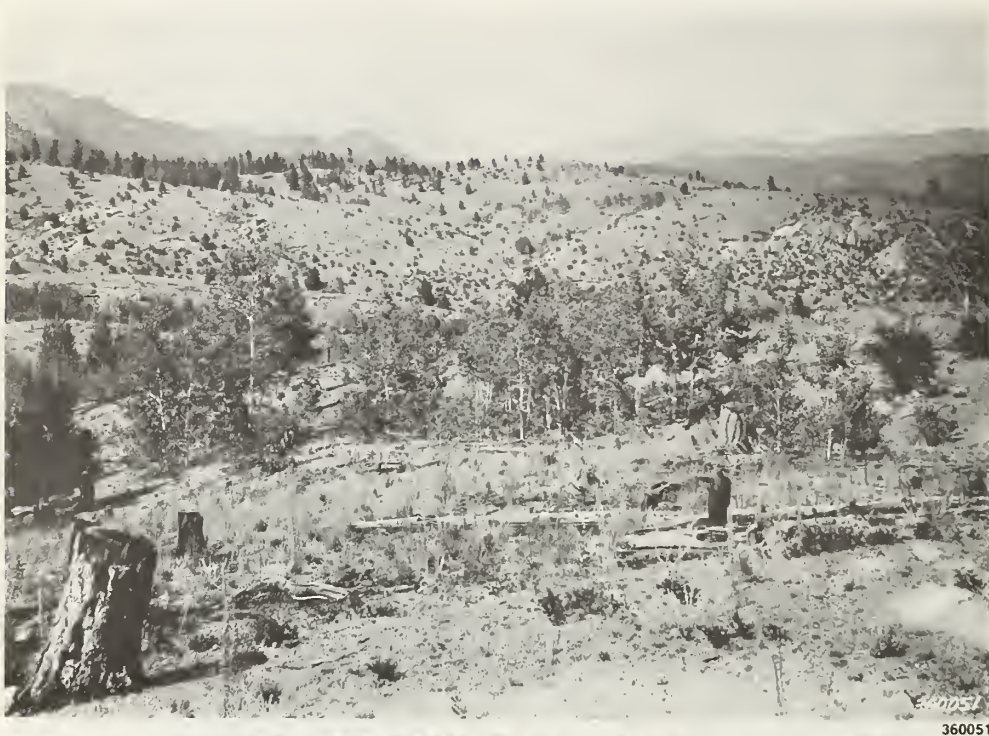
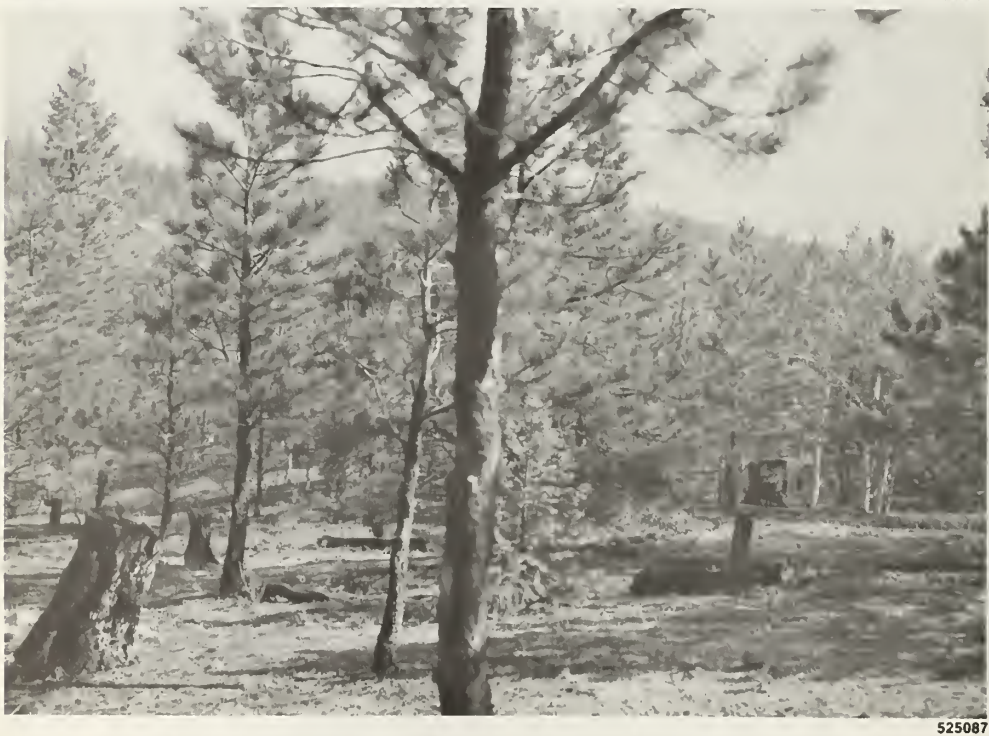
Figure 14.—View north of camera point No. 39. Sheep Nose is in the left background.

Two views at the upper reaches of the watershed are shown from camera point 39 north and west (figs. 14 and 15). Most of this area was replanted to ponderosa pine in the early 1930's. The area shown in fig. 15 was also planted at the same time. The presence of aspen on both sites in 1937 provided

evidence of good sites for the reforestation efforts. Estimated average tree height in both areas is 3.6 m (11.9 feet) and measured diameter averages 8.7 cm (3.4 inches). The herbaceous ground cover that was present in 1937 appears to be on the decline.

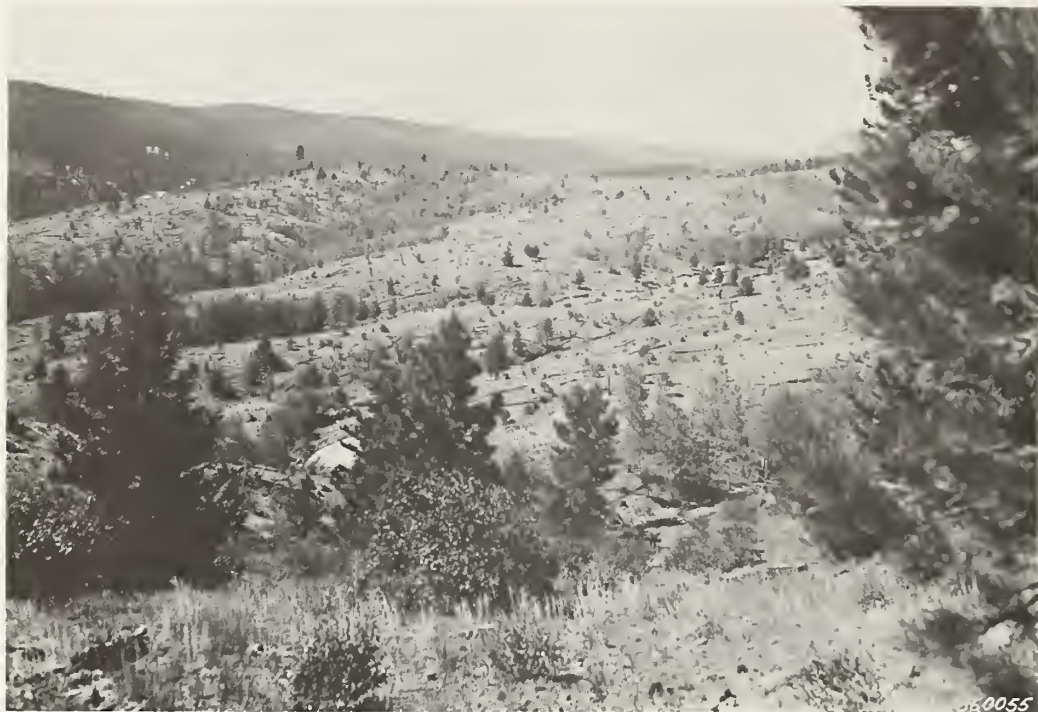
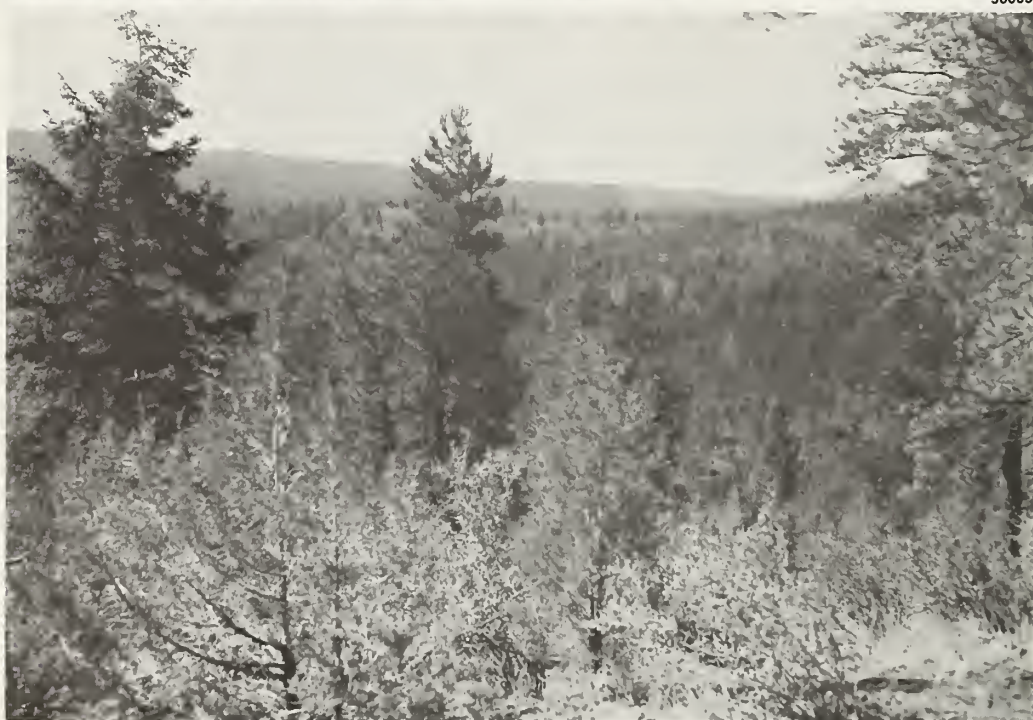
Figure 16.—View south of camera point No. 44. Signal Butte is in right background and near upper reaches of the watershed.

A south facing aspect (camera point 44 south) in the same general area as shown in figures 14 and 15 was also planted to both ponderosa pine and Rocky Mountain juniper (fig. 16). Stumps present over the general region shown in figures 14, 15, and 16

further illustrate that usable timber was produced in the past. Successful reestablishment of ponderosa pine and juniper over the area gives some assurance the area will again produce usable wood products and shrubby ground cover.
